# Bonded Concrete Overlay Performance In Illinois

**FINAL REPORT**  
**PHYSICAL RESEARCH REPORT NO. 143**  
**JUNE 2002**

**Illinois Department of Transportation**

BONDED CONCRETE OVERLAY PERFORMANCE  
IN ILLINOIS

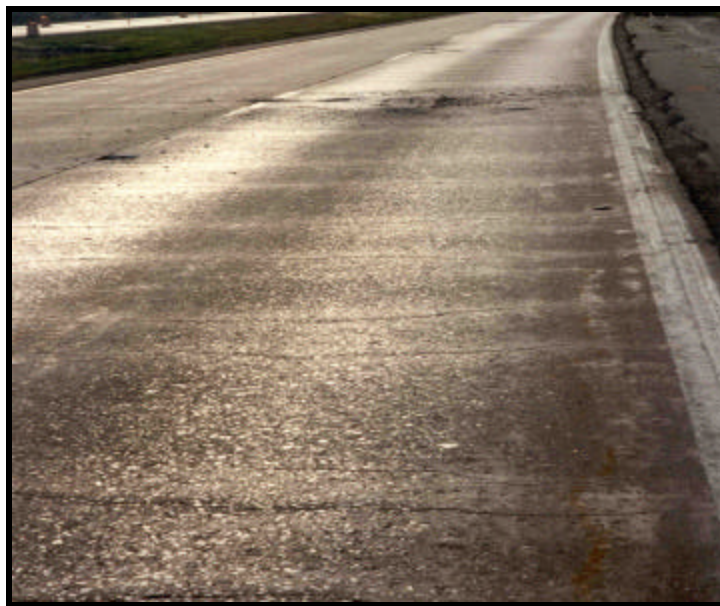
Figure 3  
Interstate 80 Before Rehabilitation

The existing 8-inch CRC pavement on Interstate 80 was constructed in 1965. The shoulders were 12-inch bituminous concrete and there were no underdrains placed during original construction. The existing pavement displayed a frequent amount of medium severity, transverse cracking and a significant amount of centerline distress prior to the rehabilitation. Figure 3 illustrates a representative area of the Interstate 80 pavement before rehabilitation. Prior to placing the bonded concrete overlay, the existing pavement was patched with full-depth and partial depth patches. In addition, any bituminous patch material found on the surface was removed.

Full-depth patches were placed at areas with medium to high severity distresses. Eleven patches were placed in the eastbound lanes and 28 were placed in the westbound lanes. These patches were “Class A” patches, which included full-depth pavement removal and CRCP replacement. The combined area of these patches was 1.23 percent of the total project roadway area.

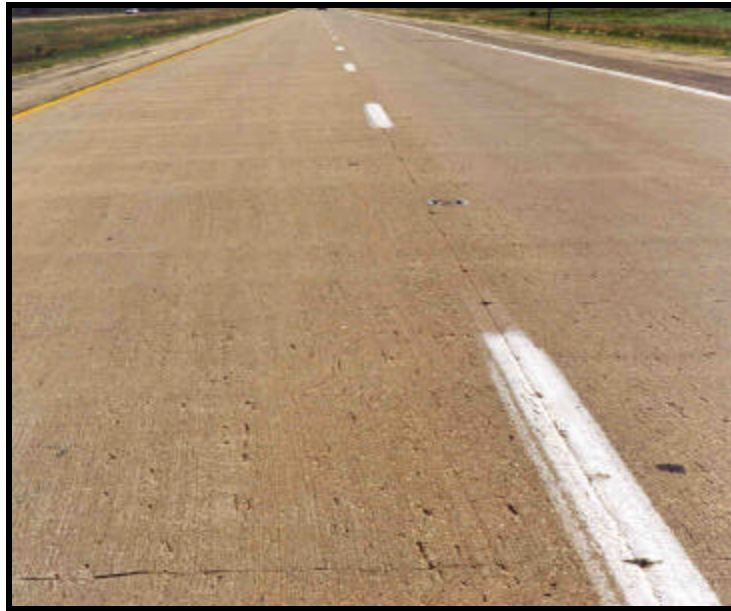
Figure 5  
Interstate 88 Before Rehabilitation

The existing 8-inch CRC pavement on Interstate 88 was constructed in 1975. The shoulders were 11-inch bituminous concrete and there were crushed stone french drains placed with the original construction. The pavement displayed minor distress

prior to the overlay. Figure 5 is a typical view of this section prior to the overlay. Full-depth and partial-depth patches were placed in the existing pavement before the overlay was constructed.

Full-depth patches were placed at areas with medium to high severity distresses. Thirty patches were placed between the eastbound and westbound lanes. These patches were “Class A” patches, which included full-depth pavement removal and CRCP replacement. The combined area of these patches was 0.55 percent of the total project roadway area.

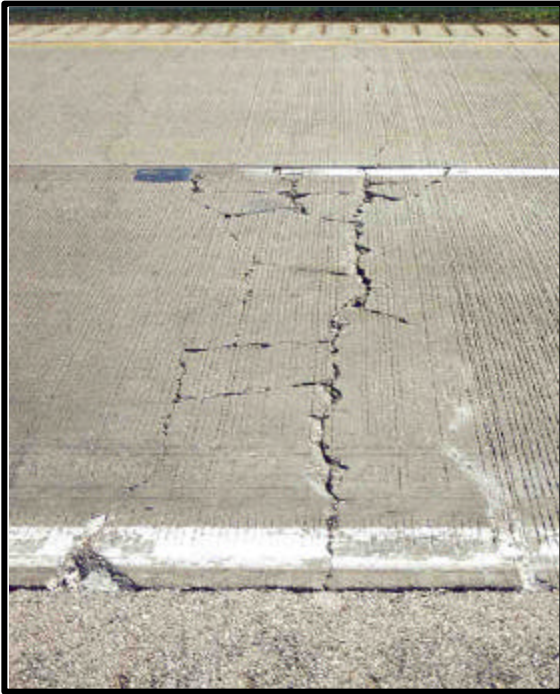
Figure 11  
Interstate 80 High Severity Crack

The post-construction distress surveys of the Interstate 80 project indicated that the eastbound lanes have deteriorated more rapidly than the westbound lanes. A large number of working, low severity, transverse cracks were found in the eastbound lanes within two years after construction. The three year survey indicated that many of these cracks had propagated into medium and high severity cracks. Examples of this type of

distress may be found in Figures 11 and 12. Eventually, these cracks developed into areas of edge-of-pavement punch-outs and centerline spalling. An example of this may be found in Figure 13. The eastbound lanes continue to deteriorate at an increasing rate.

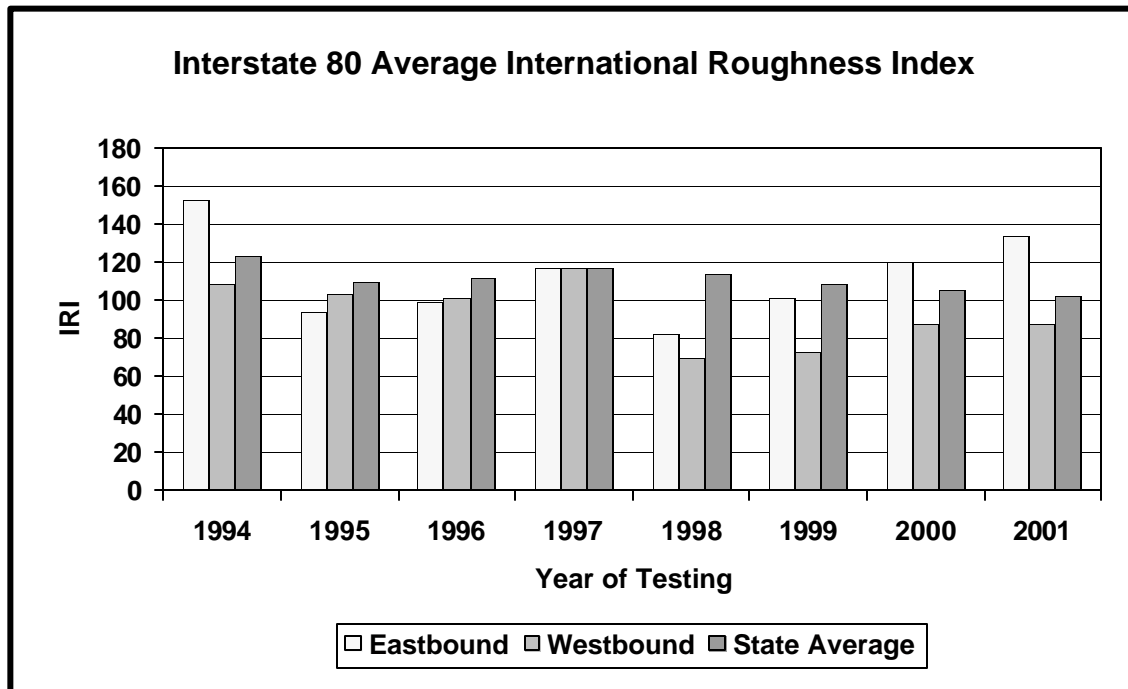
Figure 14  
Interstate 80 Average International Roughness Index

The data for the Interstate 80 project indicate that the BCO dramatically improved the pavement smoothness in the eastbound direction, while only slightly improving the westbound direction. By 1997, both directions were rougher and comparable to the level of the statewide average. The patching completed in 1998 improved the pavement smoothness in both directions. The patching and maintenance that has been completed since 1998 has had little effect on the IRI in either direction. The IRI values for the eastbound lanes are increasing rapidly (from 82 to 134 over the last four years), while the westbound lanes have only increased from 70 to 87 over the same four years.

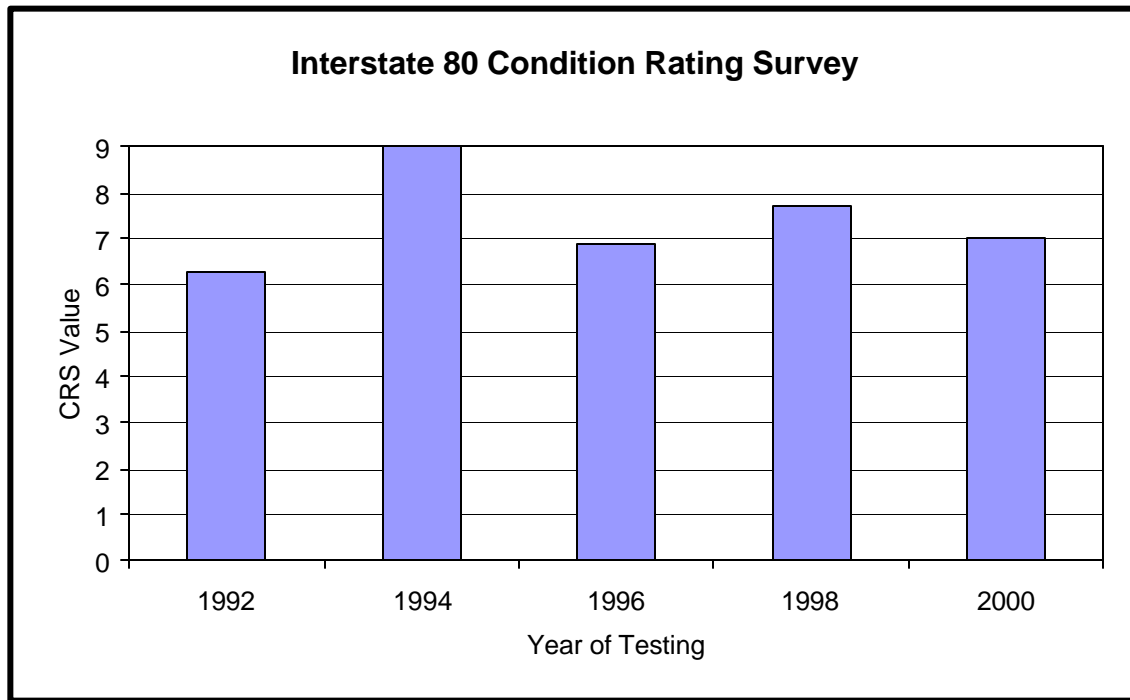
Figure 16  
Interstate 80 Condition Rating Survey

The pre-overlay CRS value for Interstate 80 had fallen to a 6.3 value. This is still within the “good” category; however, a section of interstate that falls below a rating of 6.5 typically is scheduled for rehabilitation. Due to the construction of the overlay in 1994 and 1995, the 1994 CRS value was set at 9.0. The CRS value quickly fell back into the “good” category with a 6.9 by 1996 and only improved to a 7.7 with the patching contract in 1998. In spite of the patching contract in 2000, the CRS value was determined to be 7.0.

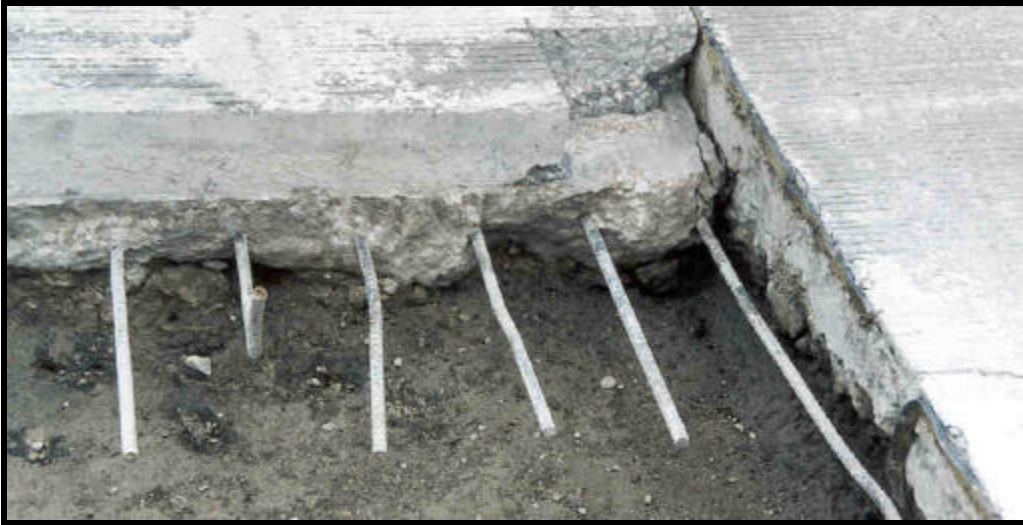
Figure 18  
Full-Depth CRC Patch

The decision to use a full-depth or partial-depth patch was based on a visual survey and sounding of the pavement around a crack. Working cracks that developed into edge-of-pavement punchouts were rehabilitated with a full-depth patch. All moderate to severe transverse cracks were rehabilitated with a partial-depth patch. The size of the partial-depth patches was determined by sounding the pavement around the crack to determine the area of delamination. In some cases, a partial-depth patch was converted to a full-depth patch once the original pavement was exposed and the condition was rated.

A full-depth patch included replacement of the CRC pavement and the overlay as one monolithic patch. The CRC reinforcement was replaced in the original pavement; however, there was no reinforcement added to the concrete overlay. Partial-depth patches included replacement of the overlay only. The existing overlay was removed in these areas, and the original surface was cleaned and sand blasted for texture. Figures 18 and 19 illustrate a full-depth and partial-depth patch, respectively.
